**DEPARTMENT OF TRANSPORTATION****DIVISION OF ENGINEERING SERVICES**

Contract #: 04-0120F4Cty: SF/ALA Rte: 80 PM: 13.2/13.9File #: 1.28**WELDING INSPECTION REPORT****Resident Engineer:**Siegenthaler, Peter**Address:** 333 Burma Road**City:** Oakland, CA 94607**Report No:** WIR-016826**Date Inspected:** 15-Sep-2010**Project Name:** SAS Superstructure**OSM Arrival Time:** 1000**Prime Contractor:** American Bridge/Fluor Enterprises, a JV**OSM Departure Time:** 1830**Contractor:** American Bridge/Fluor Enterprises, a JV**Location:** Job Site

Caltrans Office of Structural Material (OSM) Quality Assurance Inspector (QAI) Joselito Lizardo was present at the Self Anchored Suspension (SAS) job site as requested to perform observations on the welding of components for the San Francisco Oakland Bay Bridge (SFOBB) Project.

## WELDING INSPECTION REPORT

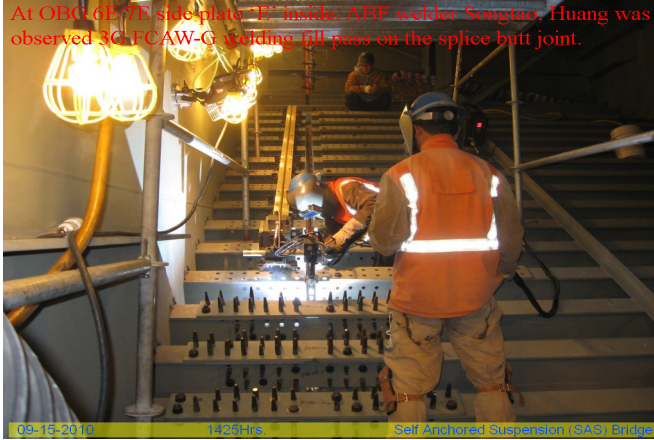
09-15-2010 1428Hrs Self Anchored Suspension (SAS) Bridge

At OBG 6E/7E side plate 'E' (3100mm to 7955mm) inside, QA randomly observed ABF/JV qualified welder Sungtao, Huang ID # 3794 perform CJP groove (splice) welding root then fill pass on the splice butt joint. The welder was observed performing automatic welding in the 3G (vertical) position utilizing a dual shield Flux Cored Arc Welding (FCAW-G) with E71T-1M, 1/16" diameter wire electrode and implementing Caltrans approved Welding Procedure Specification (WPS) ABF-WPS-D15-3042B-1. The joint being welded had a single V-groove butt joint with backing bar. The splice joint was preheated and maintained to greater than 150 degrees Fahrenheit using Miller Proheat 35 Induction Heating System located at the opposite side of the plate prior/during welding. ABF Quality Control (QC) William Sherwood was noted monitoring the welding parameters of the welder. At the end of the shift, fill pass welding was still continuing and should remain tomorrow.

At OBG 6E/7E side plate 'F' inside, ABF welder Songtao, Huang was observed 3G-FC-AW-G welding full pass on the splice butt joint.

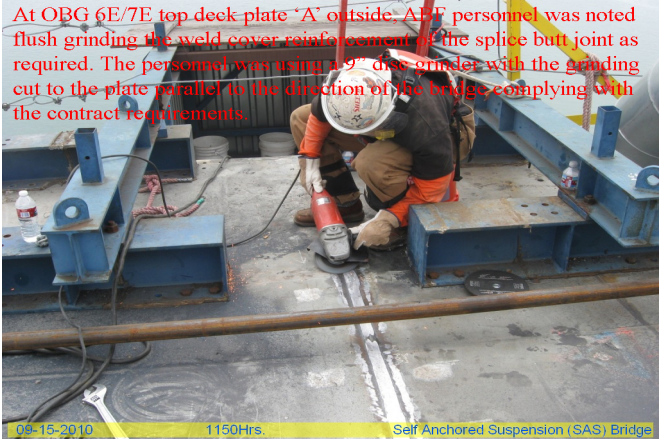
09-15-2010 1150Hrs Self Anchored Suspension (SAS) Bridge

At OBG 4W/5W side plate 'C' outside and OBG 6E/7E top deck plate 'A' outside, ABF personnel were observed flush grinding the weld cover reinforcement of the splice butt joint as required. The personnel were using the 9" disc grinder with the grinding cut of the disc to the plate parallel to the direction of the bridge complying with the contract requirements. At the end of the shift, flush grinding of the weld cover reinforcement was still continuing and should continue tomorrow.

At OBG 6E/7E top deck plate 'A' outside, ABF personnel was noted flush grinding the weld cover reinforcement of the splice butt joint as required. The personnel was using a 9" disc grinder with the grinding cut to the plate parallel to the direction of the bridge complying with the contract requirements.

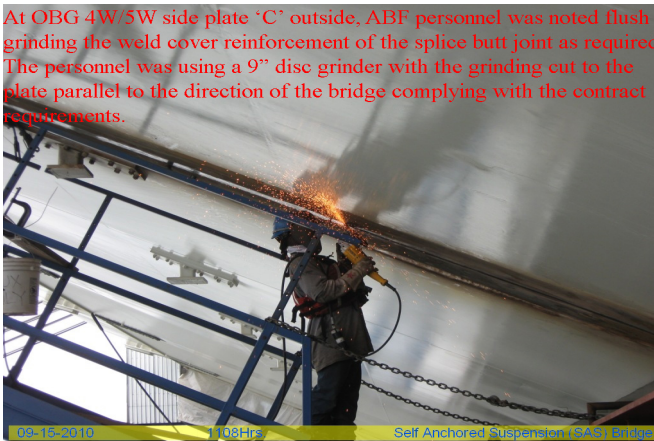
09-15-2010 1408Hrs Self Anchored Suspension (SAS) Bridge

At OBG 4W/5W side plate 'C' outside, ABF personnel was noted flush grinding the weld cover reinforcement of the splice butt joint as required. The personnel was using a 9" disc grinder with the grinding cut to the plate parallel to the direction of the bridge complying with the contract requirements.

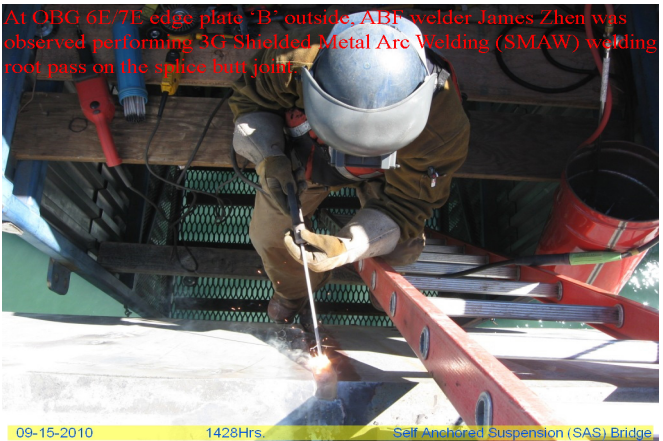
09-15-2010 1428Hrs Self Anchored Suspension (SAS) Bridge

At OBG 6E/7E edge plate 'B' outside, QA randomly observed ABF/JV qualified welder James Zhen ID #6001 continuing to perform root pass welding on the Complete Joint Penetration (CJP) splice butt joint. The welder was observed manually welding in the 3G (vertical) position utilizing a Shielded Metal Arc Welding (SMAW) with 1/8" diameter E7018H4R electrode and implementing Caltrans approved Welding Procedure Specification (WPS) ABF-WPS-D15-1040B. The joint being welded has a single V-groove butt joint with copper backing bar. During welding, ABF Quality Control (QC) Steven Mc Connell was noted monitoring the welding parameters of the welder. At the end of the shift, fill pass SMAW welding was still continuing and should remain tomorrow.

At OBG 6E/7E edge plate 'B' outside, ABF welder James Zhen was observed performing 3G-Shielded Metal Arc Welding (SMAW) welding root pass on the splice butt joint.
